### CASE STUDY: WHEEL DEFECT DETECTION AT DEPOT

Customer	De Lijn Antwerpen
Location	Antwerpen, Belgium
Duration	Oct 2008 – ...
Application domain	Asset Management- Railway

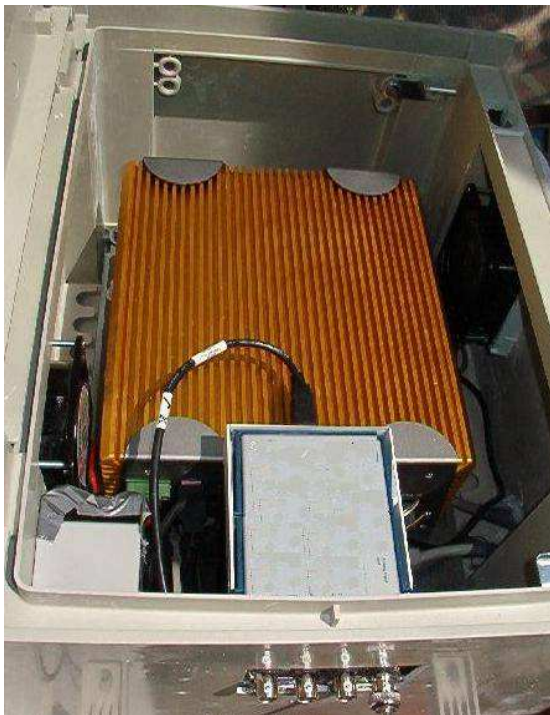
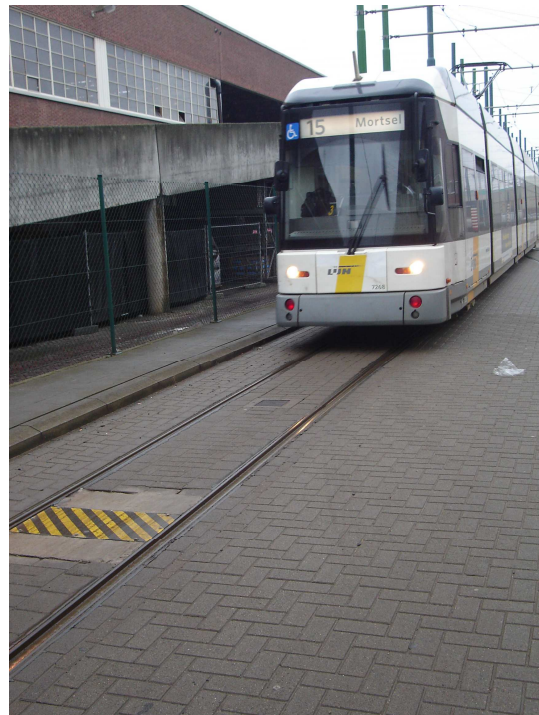
A monitoring system was installed at the entrance of the Antwerp tram depot, in order to identify trams with defected wheelsets. Defect such as flats and cracks are detected, based on the vibrations caused by the wheels.
