CASE STUDY A071: WHEEL DEFECT DETECTION AT DEPOT

| Customer | De Lijn Antwerpen |
| Application domain | Asset Management- Railway |

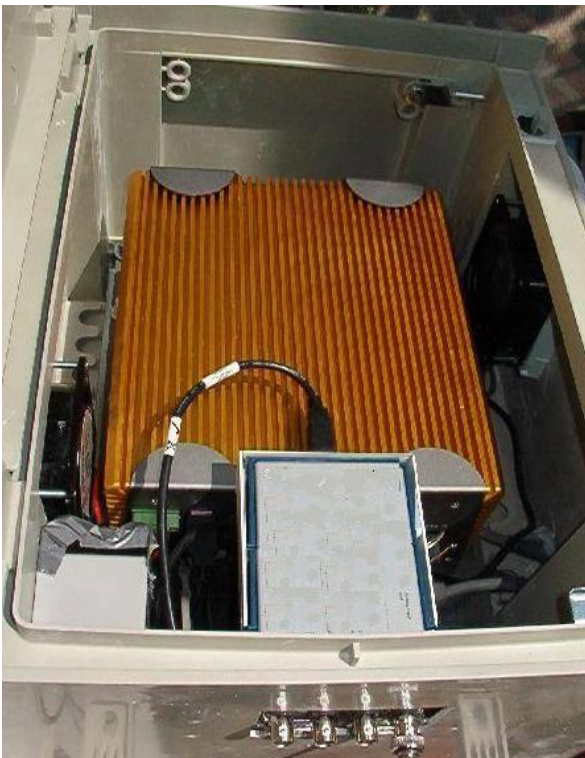
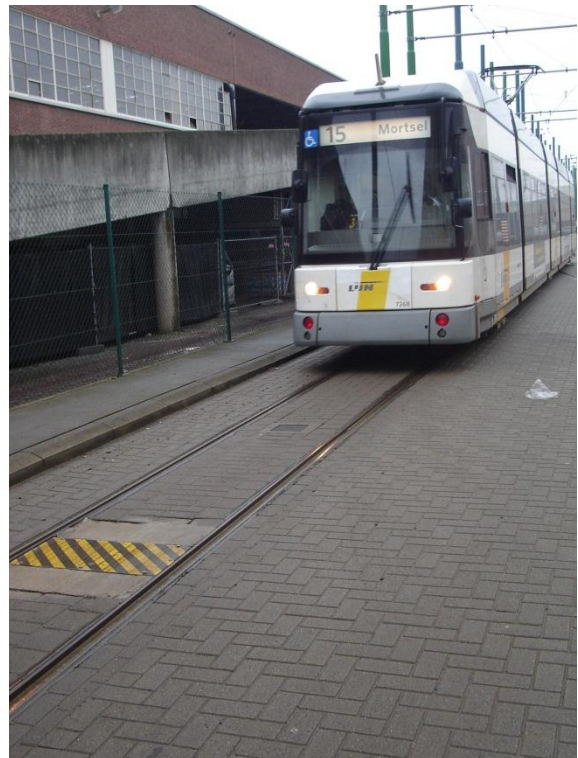
A monitoring system was installed at the entrance of the Antwerp tram depot, in order to identify trams with defected wheelsets. Defect such as flats and cracks are detected, based on the vibrations caused by the wheels.
